Infrastructure Management Services

## A GUIDE TO

# KEY INDICATORS OF FAILING PAVEMENT

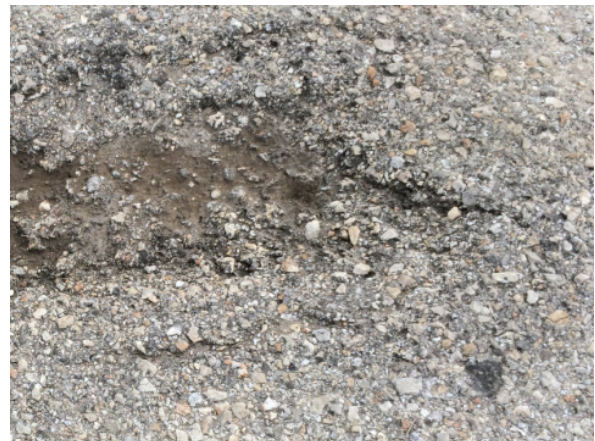
### RAVELING

The loss of fine aggregate materials on the pavement surface measured by the severity and number of square feet affected. This is an NLAD caused primarily by normal weathering. This distress is also commonly found in areas where there is heavy traffic around a turning area and the friction of tires can cause the surface materials of the road to come loose. Raveling reduces the friction of tires and increases roughness on the pavement surface. Raveling can spread very quickly.

Raveling is repaired by a patch or through the removal of the damaged pavement and a replacement overlay.

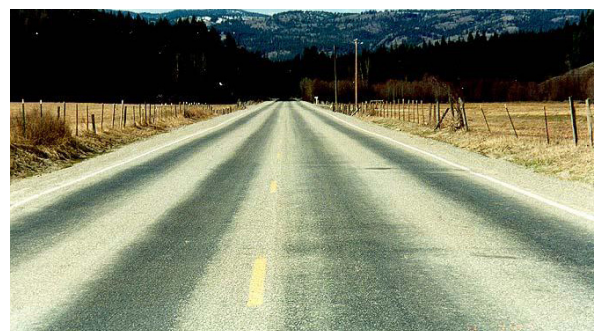
### BLEEDING

The presence of free asphalt binder on the roadway surface caused by too much asphalt in the pavement or insufficient mixing of the aggregate materials. The result is a pavement surface with low skid resistance, especially when wet, and is measured by the amount and severity of the area. This is an NLAD that is commonly found in wheel paths.

Bleeding can be addressed through the light application of coarse sand (to absorb the excess asphalt binder) major bleeding should be shaved away using a motor grader or heater planer.

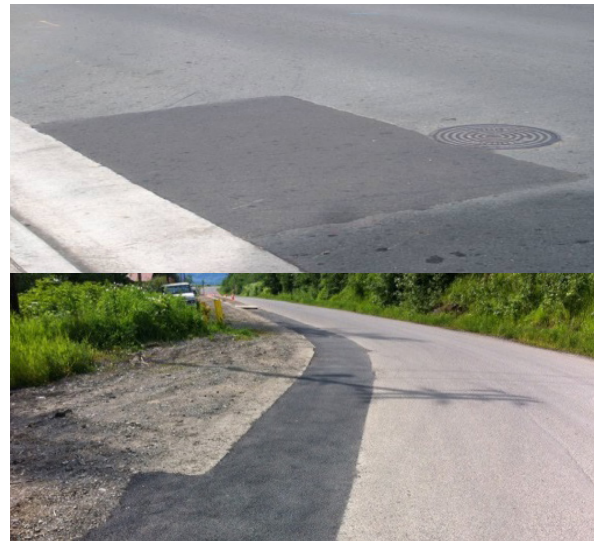
## PATCHING

An area of the road that has been replaced by new material to repair the existing pavement. A patch is always considered a defect no matter how effective it is. When the majority of a roadway surface is covered by a patch, such as a large utility replacement, the rating of the patch is minimized and the patch it is considered a NLAD. When a patch is used to cover a defect such as alligator or edge cracking it may reflect on the roads base strength.

Patching is already, itself, considered a pavement rehabilitation, it is still important to make sure it is water proof sealed and smoothed into the existing pavement.

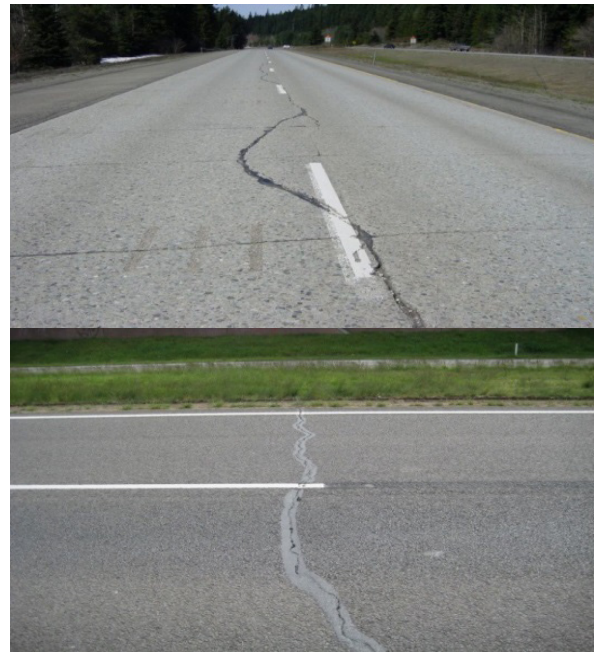
## LONGITUDINAL AND TRANSVERSE CRACKS

These are quantified by their length and width. These distresses are primarily due to weathering and not considered a LAD. Longitudinal and Transverse cracks that intertwine are the start of alligator cracking. Because of the relationship with more severe distresses such as alligator, block, and edge cracking, the appearance of longitudinal and transverse cracks are among the first visual signs that a road's base is beginning to fail. These cracks should be waterproof sealed as soon as possible to avoid further damage to the surface as well as the base of the pavement.

Most cracks of this type can be fixed through a waterproof sealing process. In the case that the cracking is severe (<1/2inch width) removal and replacement with an overlay may be needed.

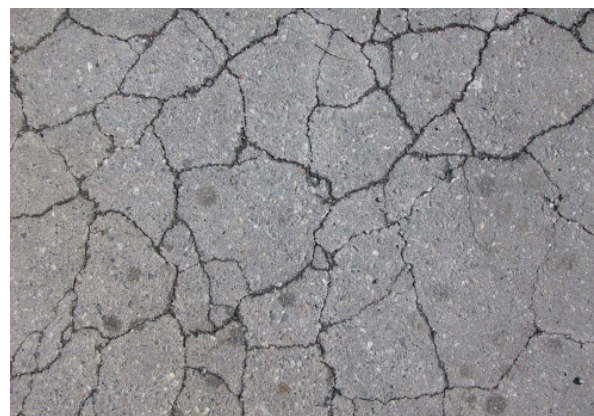
## ALLIGATOR CRACKING

Alligator cracking or fatigue cracking is quantified by the severity of the failure and number of square feet. Even at low extents, this can have a large impact on the condition score as this distress represents a failure of the underlying base materials. It is one of the most common types of LAD and can spread rapidly if left unchecked.

For this type of distress, sealing is generally not going to be effective. If the cracking is small and localized it may be dug out and replace with a Patch. A large section of alligator cracking is a common first sign of pavement structural failure and must fixed with a strong HMA Overlay. If this does not happen the cracks will soon be replaced by potholes.

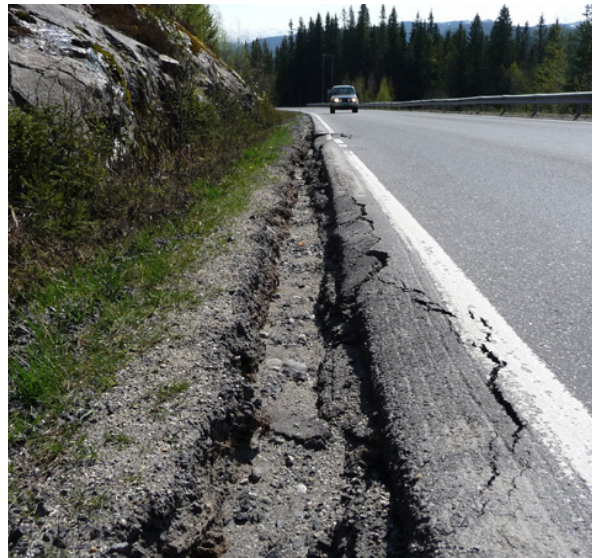
## EDGE CRACKING

Though edge cracking only appears on streets with unpaved shoulders, it can also be a sign of severe weakening of the pavement base. Edge cracking commonly occurs on rural roads without sufficient drainage. This allows water to seep under the surface of the street and begin eroding away at the base. Edge cracks may start forming from just outside the wheel path along the shoulder, but may spread very rapidly to the center of the street where much more damage will result in the form of alligator cracks and potholes. Drainage should be properly established so water cannot seep under the surface of the pavement.

This type of cracking spreads very quickly so even light edge cracking should be waterproof sealed as early as possible. If the cracking becomes more severe, damaged areas of the road must be removed and replaced with an overlay.

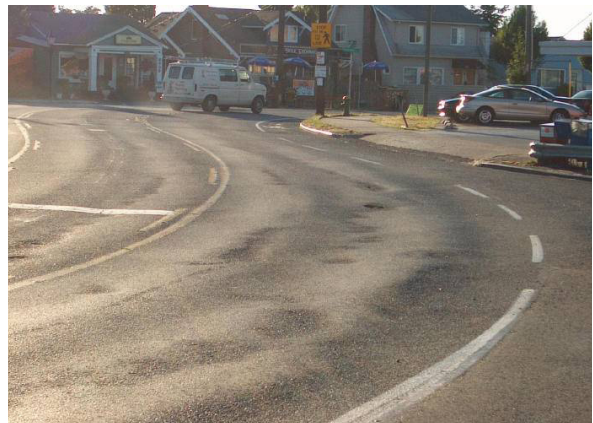
## WHEEL PATH RUTTING

Starting at a minimum depth of  $\frac{1}{4}$  inch, wheel path ruts are quantified by their depth and the number of square feet encountered. Like alligator cracking, low densities of rutting can have a large impact on the final condition score. This is a LAD that is caused by vehicle movement shifting the underlying pavement materials and is considered a pavement distortion.

Though slight rutting is often ignored until farther distresses are observed, heavy rutting (>1/3 inches deep) can be a concern and should be leveled and replaced by an overlay.

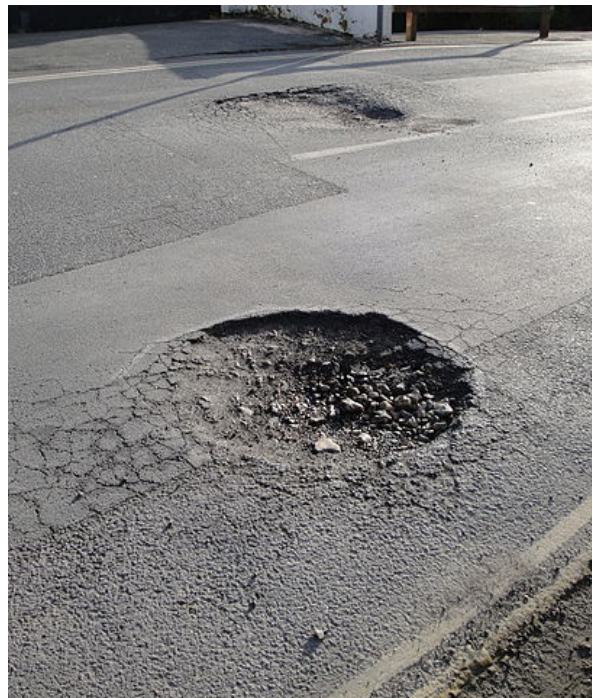
## POTHOLES

These are commonly seen in areas with lower structural standards and poor drainage where an already present distress, such as alligator cracking, has filled up with water, enough that the soil beneath the pavement has begun to erode. Combine this erosion with continued pressure from street traffic and the surface asphalt is forced out of place. This creates a hole in the pavement where the asphalt surface is completely missing. Potholes are measured in severity from low at less than 25mm to high at over 50mm. Potholes can grow and become very dangerous if left unattended to. They can severely damage tires and vehicle suspensions, and even cause serious accidents. Potholes themselves are a NLAD but they are also usually a symptom of a much greater problem with the pavement base.

These can get substantially worse over time and present a major danger to motorists so, they must be replaced with patches and fillings as early as possible.
