PICKING UP THE PIECES

Landslide disables Idaho mountain town corridor

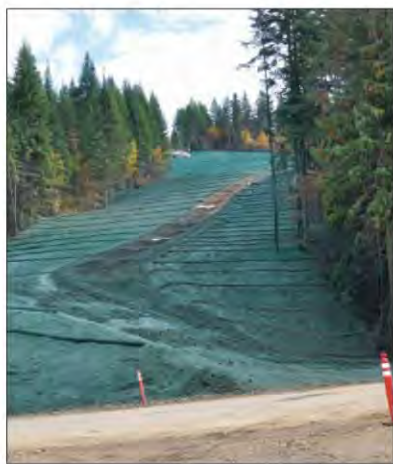
The treatment of the slope was completed just before the end of fall 2013.

During the fall of 2013, a series of BMPs were put into place at the slide site to ensure stability throughout the long Idaho winter and allow for permanent regeneration of the natural landscape. Debco Construction continued management of the project and worked to excavate the site to create a terrain that would encourage natural water flow patterns. The team trenched out rock groin diversion ditches with strategically placed curves and terraces to slow the water flow, and layered the base with a bed of crushed rock in efforts to decrease soil particle movement. Once a favorable design of the terrain was achieved, straw wattles were installed every 6 to 10 ft perpendicular to the slope surrounding the rock groin ditches. With the aforementioned BMPs in place, a team from Apex Erosion Control LLC of Clarkston, Wash., sprayed the entire eroded slope with a specially formulated hydroseeding slurry.

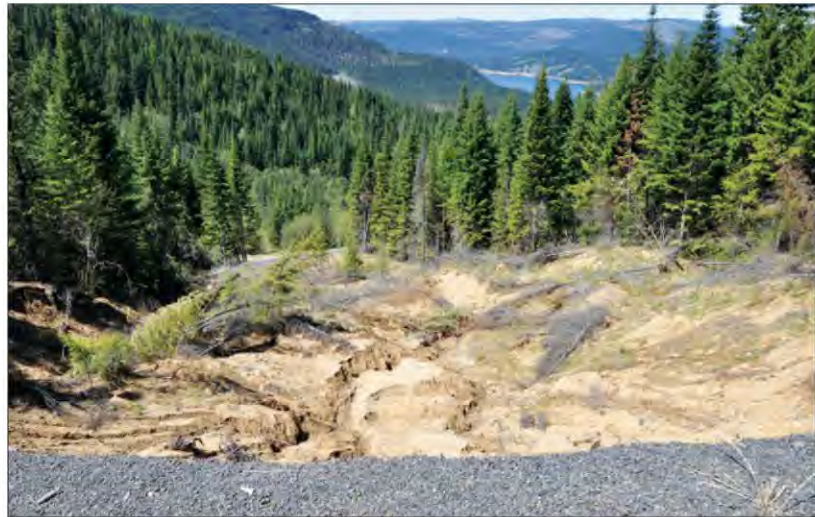
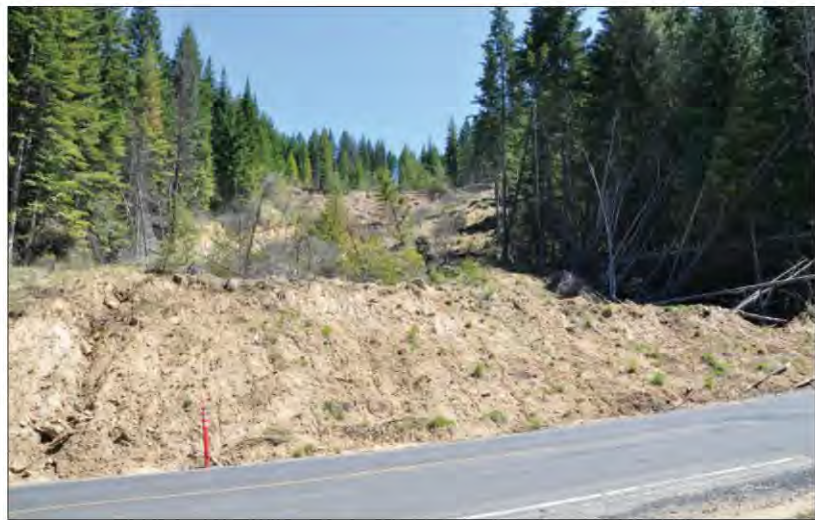
A massive landslide occurred as a result of intense runoff, causing significant damage to the road infrastructure and surrounding slopes.

By April 8, a massive landslide occurred as a result of the intense runoff, causing significant damage to road infrastructure and surrounding slopes. A horseshoe bend area at mile marker 13 of the Dent Bridge Road, which serves as the main travel corridor between the mountain towns of Orofino and Elk River, was destroyed. An estimated 50,000 cu ft of debris slid down the mountain, taking almost the whole width of the road with it, and continued to slide down to a lower switchback and completely covered the road below. The Clearwater County Sheriff's Office stated that once the landslide finally came to rest after movement throughout the day, it was about 70 ft wide and deep and stretched down an approximately 800-ft-long hill slide slope.
